By CHICAGO BOARD OF UNDERWRITERS

MAY 15th, 1922

**CHICAGO BOARD OF UNDERWRITERS' REPORT ON CHICAGO FIRE
OF MARCH 15TH, 1922.**

**Embracing C. B. & Q. R. R. Co.'s Office Building, Atlantic and
Austin Buildings and Others.**

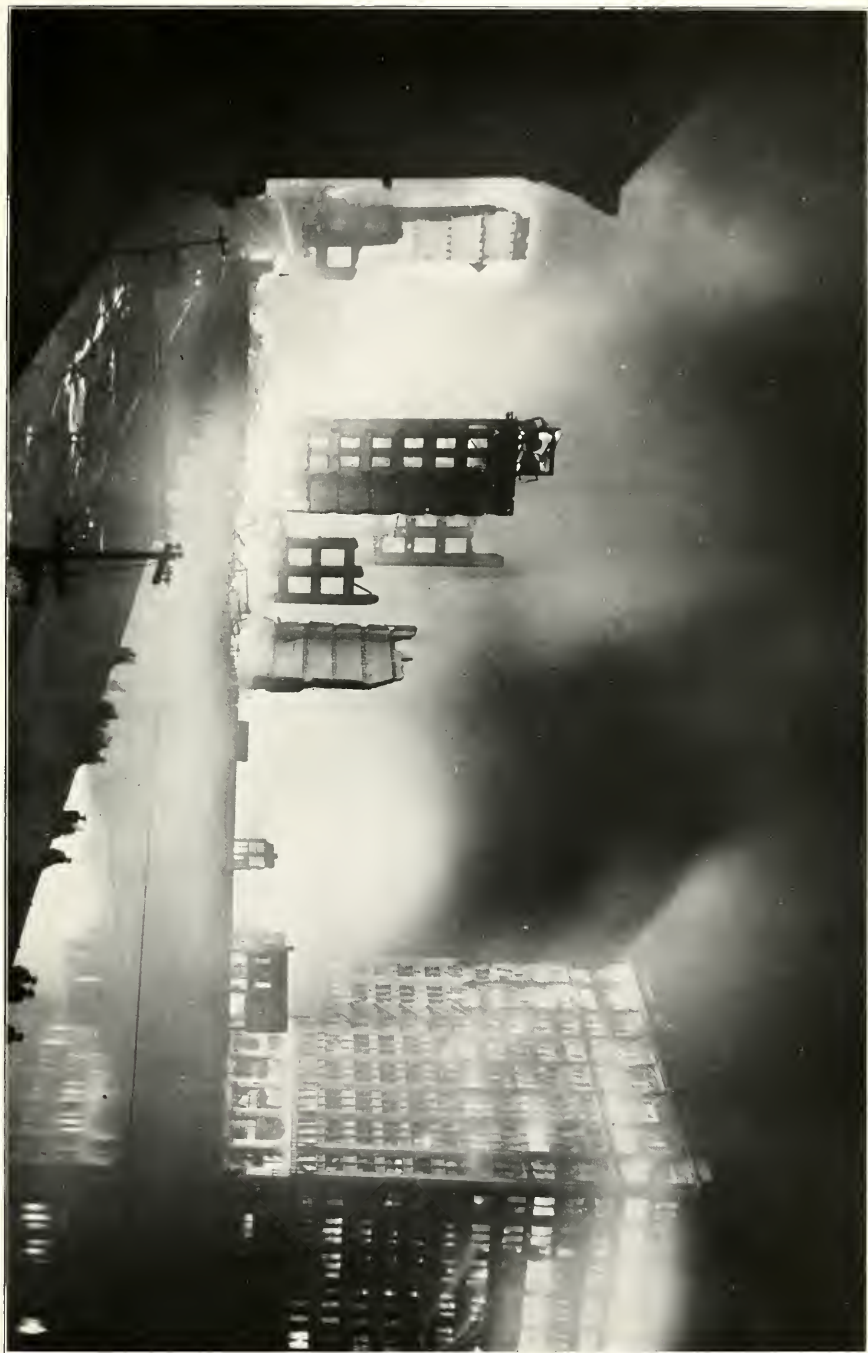
Fig. 1A.
BURNING BUILDINGS AT 2:45 A. M. BURLINGTON BUILDING AT RIGHT.
(PHOTO BY DAILY NEWS)

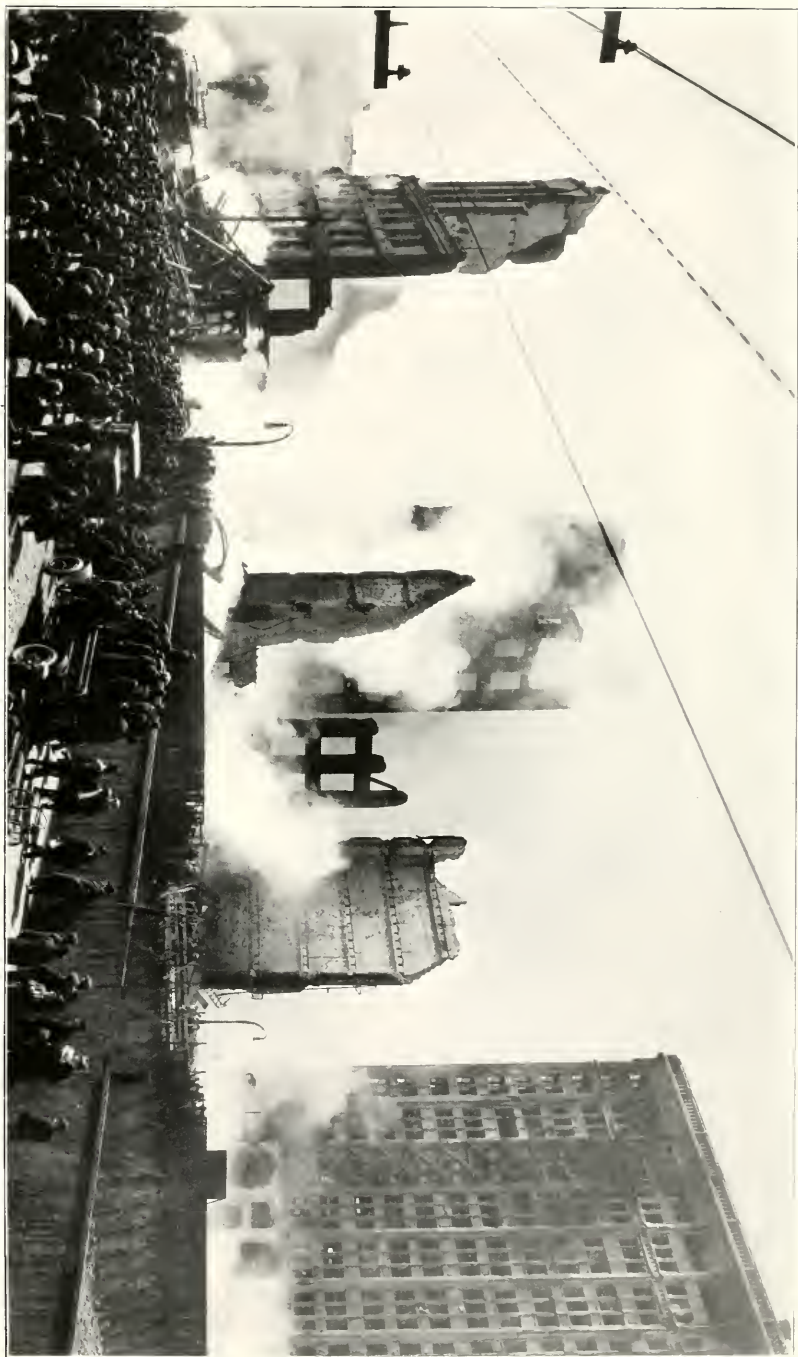
FIG. 1B.
PRINCIPAL BUILDINGS DESTROYED OR DAMAGED, LOOKING SOUTH.
(PHOTO BY INTERNATIONAL)

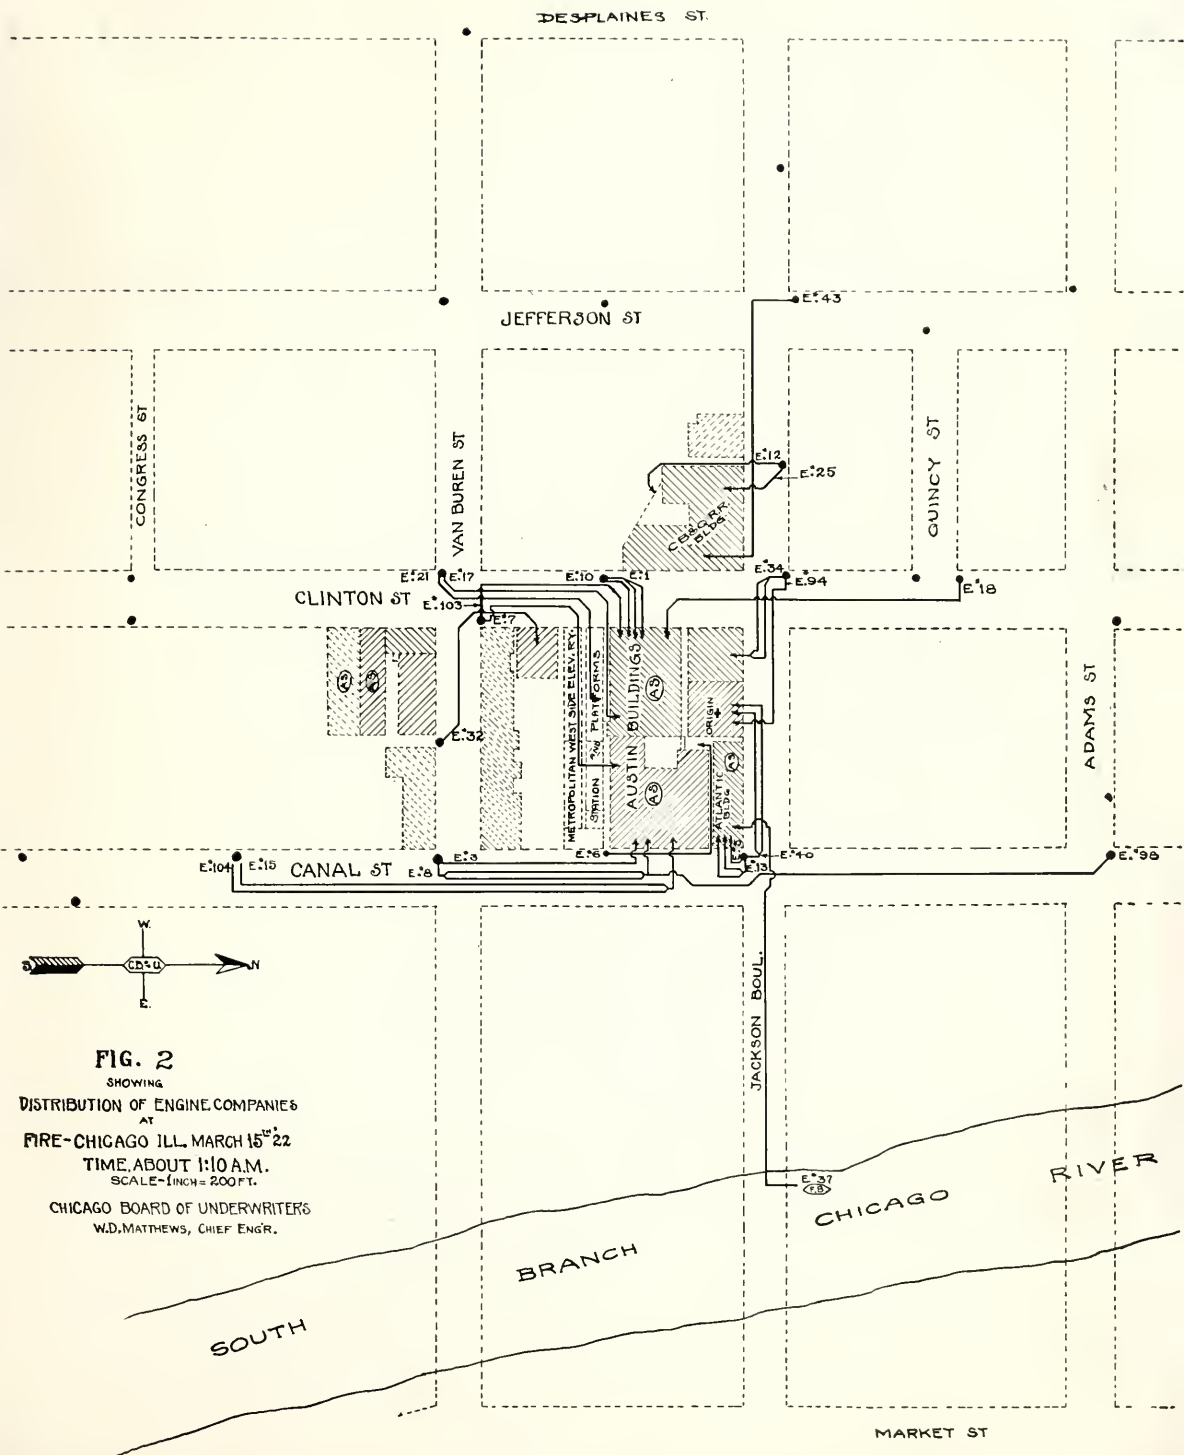
Fig. 2 shows the distribution of companies at about 1:10 A. M., or 20 minutes after the first alarm was sent out. At this time there were seven engines and a fire boat working on the east and north sides of the fire and eleven engines working on the west and south sides of the fire. Apparently the firemen had been driven out of the Jackson Boulevard buildings, the interior court yard and the northern sections of the Austin Buildings and were retreating from the Atlantic Building.

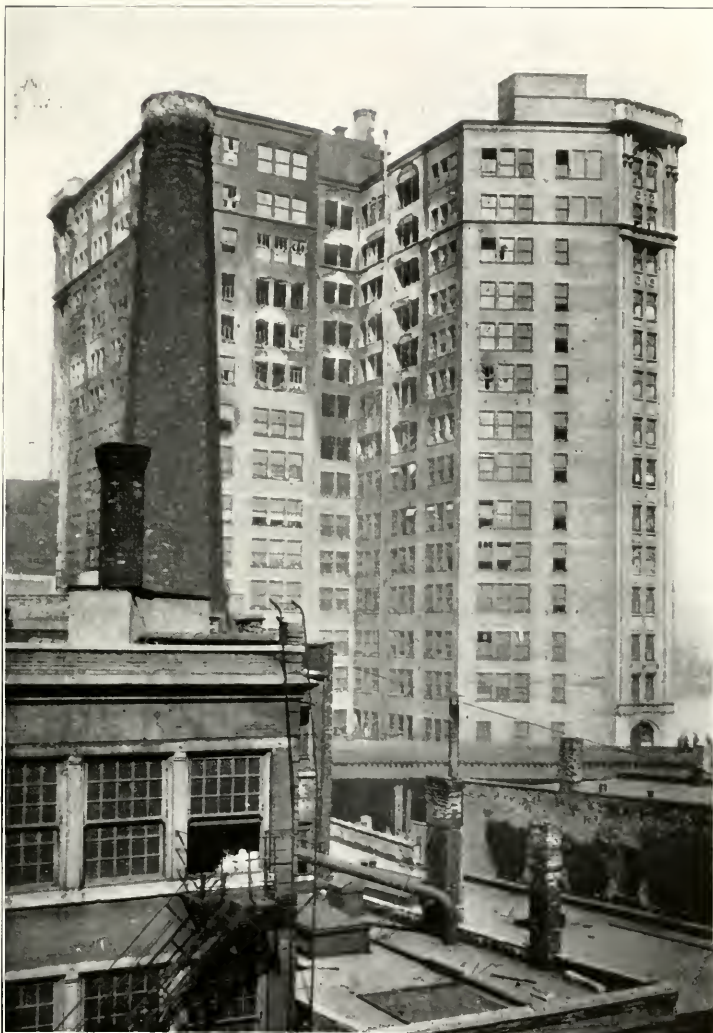
Fig. 4.
REAR ELEVATION OF BURLINGTON BUILDING.

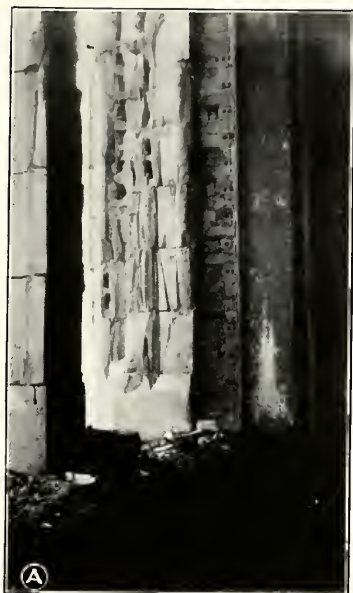
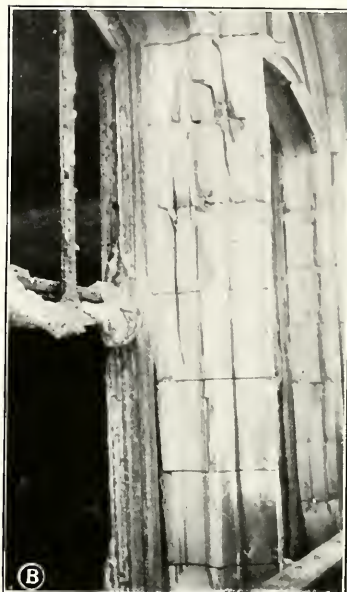
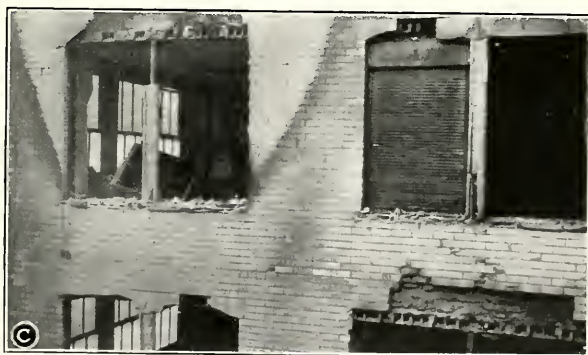
Fig. 5.

- A. SHOWING HOLLOW BRICK PROTECTION ON EXTERIOR COLUMN, AND DAMAGE TO TERRA COTTA.
- B. DAMAGED TERRA COTTA; WIRED GLASS WINDOW AT EAST FIRE ESCAPE.
- C. ROLLING STEEL SHUTTER ON VENTILATING FAN INTAKE.

Ornamental mat glazed terra-cotta facing was used on north and east walls; glazed terra-cotta bricks on south and west walls and in court. There was damage to this material on all four sides of the building, the heaviest damage occurring in east wall, and in the court walls. Figures 5 and 6 indicate the amount of spalling that took place, but it is believed that some of this damage may be attributed to falling sash weights. In addition to the spalling, the blocks that were most exposed were badly checked; the checks, in several blocks examined, extending through the blocks.

Labeled wired glass windows were installed in openings in south and west walls, and in three openings each floor above first at fire escape, east wall. Those in east wall were intact below the 9th floor, the ones above suffering in varying degrees, but generally softening and running out of frames onto sills, or dropping over steam radiators located just below the sills. Those in west wall, above the 9th floor, experiencing even greater heat, behaved in the same manner permitting flames to lap up the wall and damage the terra-cotta brick facing. **Also see Vertical Shafts.**

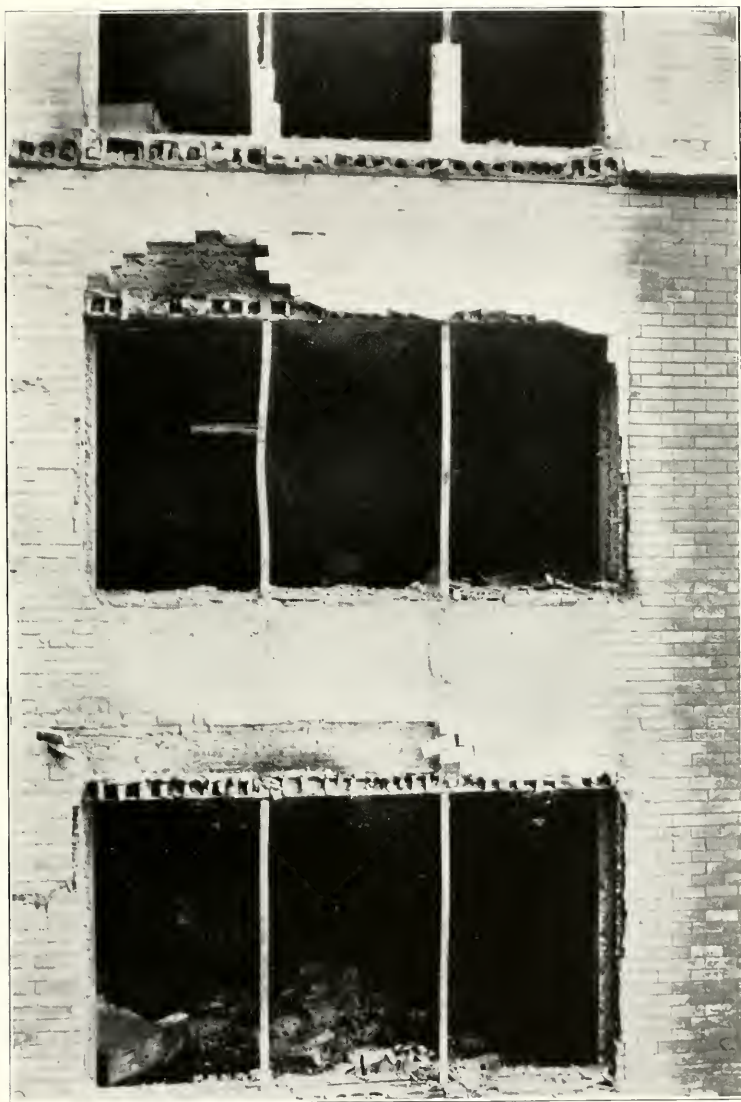
Fig. 6.
EAST WALL OF COURT, 13TH, 14TH AND 15TH FLOORS. NOTE DAMAGE TO TERRA
COTTA BRICK.

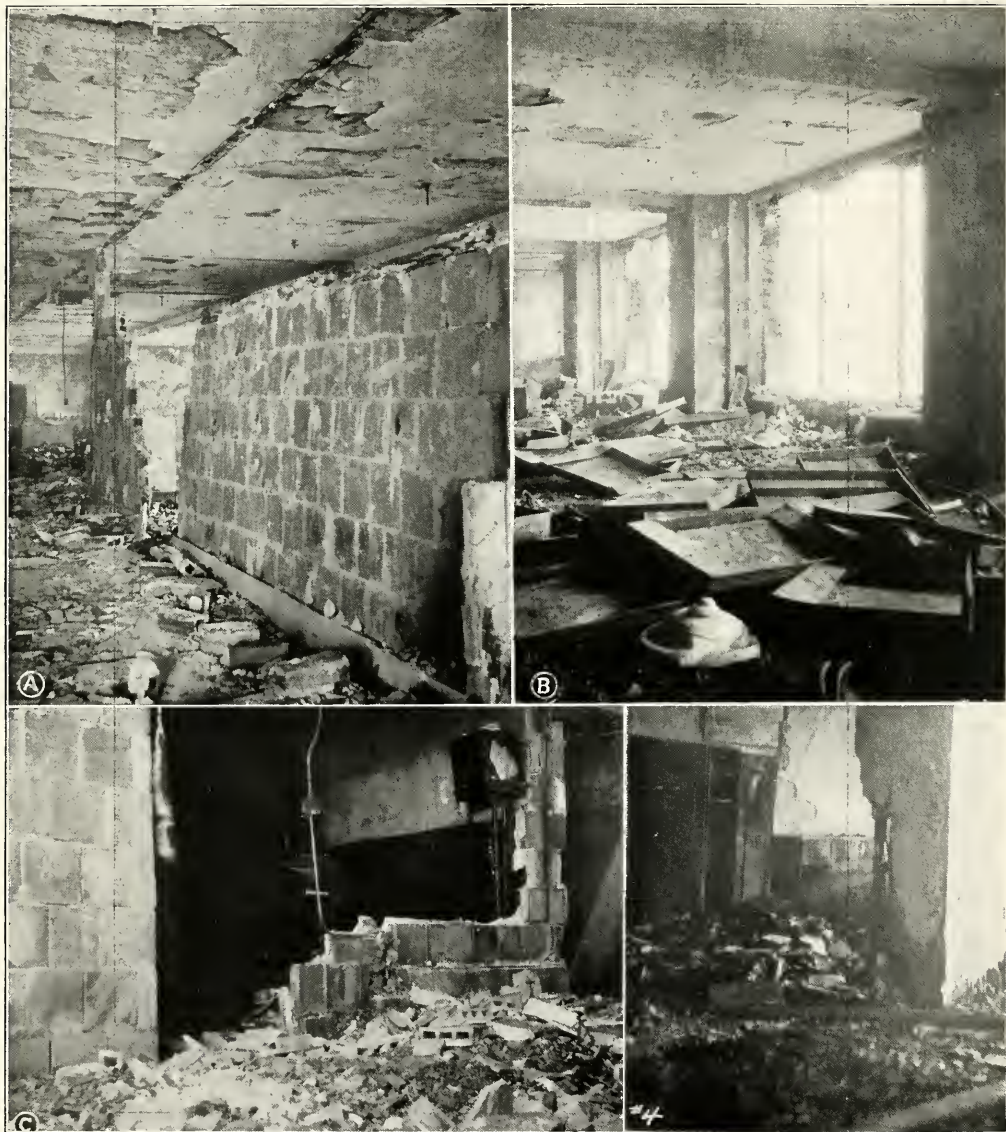
Fig. 7.

- A. SHOWING DAMAGE TO HOLLOW TILE PARTITION AND PLASTERED CEILING.
- B. METAL FILING CABINETS.
- C. VENTILATING FAN ROOM.
- 4. INTERIOR COLUMN AT RIGHT; DAMAGED PORTION IS PIPE ENCLOSURE.

There were no plaster block partitions in this building. All partitions were 3-inch hollow-tile laid on the cinder concrete fill on tile floor arches with no bracing except wooden door frames. Nearly all of these failed, due principally to bulging, which was so great that some sections fell out and others were pulled down by firemen as a measure of safety to themselves.

The metal furniture in use consisted principally of filing cabinets and proved absolutely no protection for the combustible contents which were ignited either by direct flame or excessive heat. The weight of records, together with the heat, caused the cases to buckle and fail at the welded joints. See Figure 7 (b).

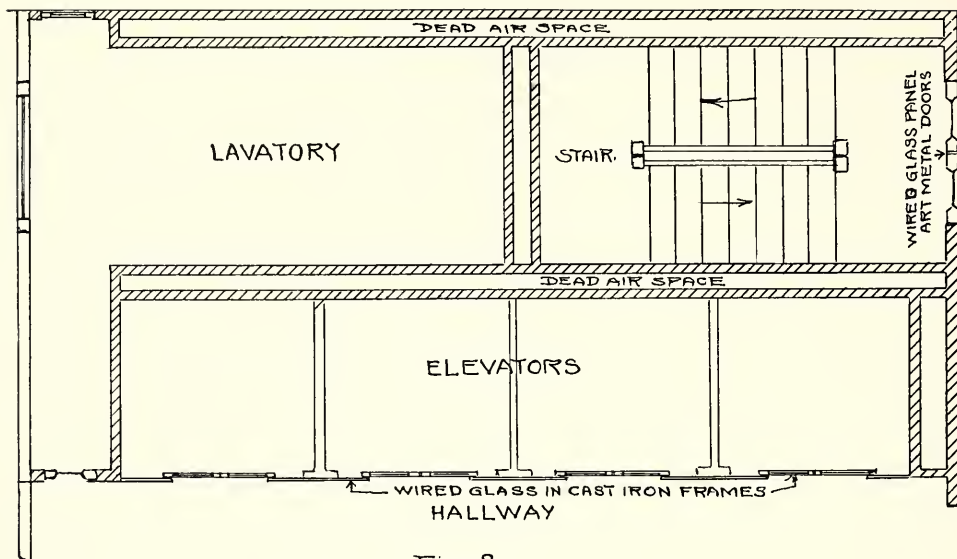
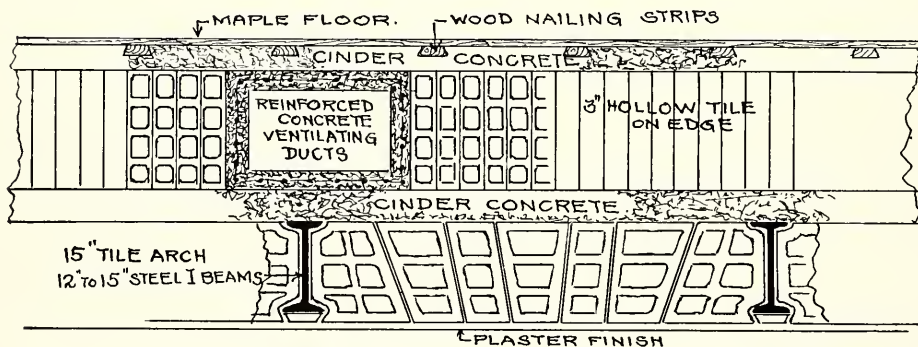
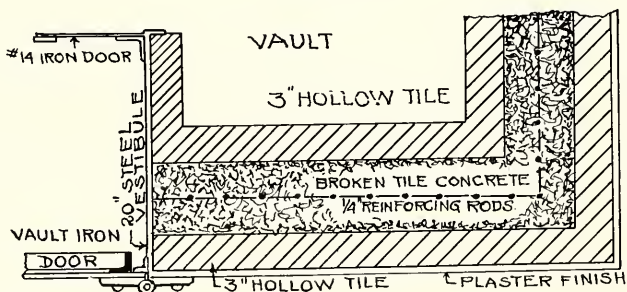
- A. SHOWING CONSTRUCTION OF MAIN STAIR SHAFT AND ELEVATOR BANK.
- B. TYPICAL FLOOR CONSTRUCTION WHERE VENTILATING DUCTS WERE INCLUDED.
- C. TYPICAL VAULT CONSTRUCTION.

The stair enclosures, which were 3-inch tile with wired glass panel art metal (labeled corridor) doors, held very well. The stair in southeast corner of building showed no sign of failure except on top floors where several transom lights failed; there was evidently a cold draught up this stair as wired glass that had softened slightly was bulged toward interior of building and the variation of temperature was evidenced by the fact that the outer surface of the glass had sagged and run in places, while the inner surface was intact. The main stair shaft did not fare quite so well, numerous wired glass panels failing entirely. However, the hand-rails, which was the only combustible material present, were scorched on only two floors. This stair was used by the department in fighting the fire.

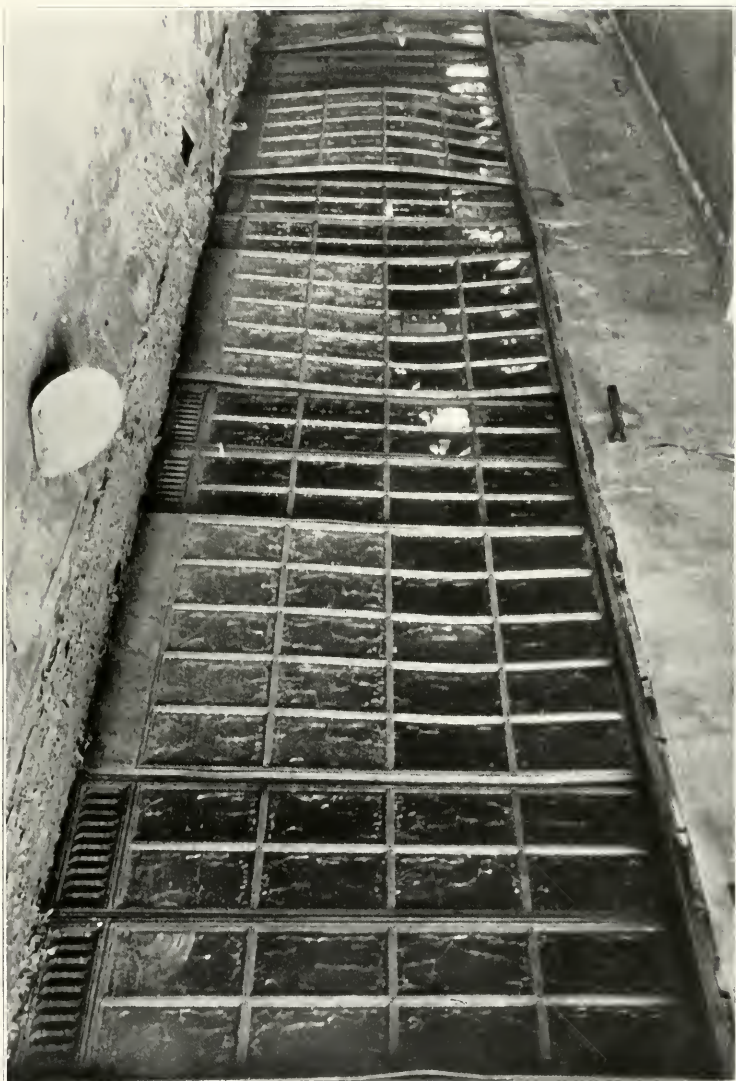
Marble flooring and wainscoting, principally in hallways, failed completely, partly from heat and partly from breakage.

FIG. 9.
SHOWING FRONT WALL OF ONE BANK OF ELEVATORS, PERFORMANCE OF WIRED GLASS, AND
DAMAGE TO MARBLE FLOOR.

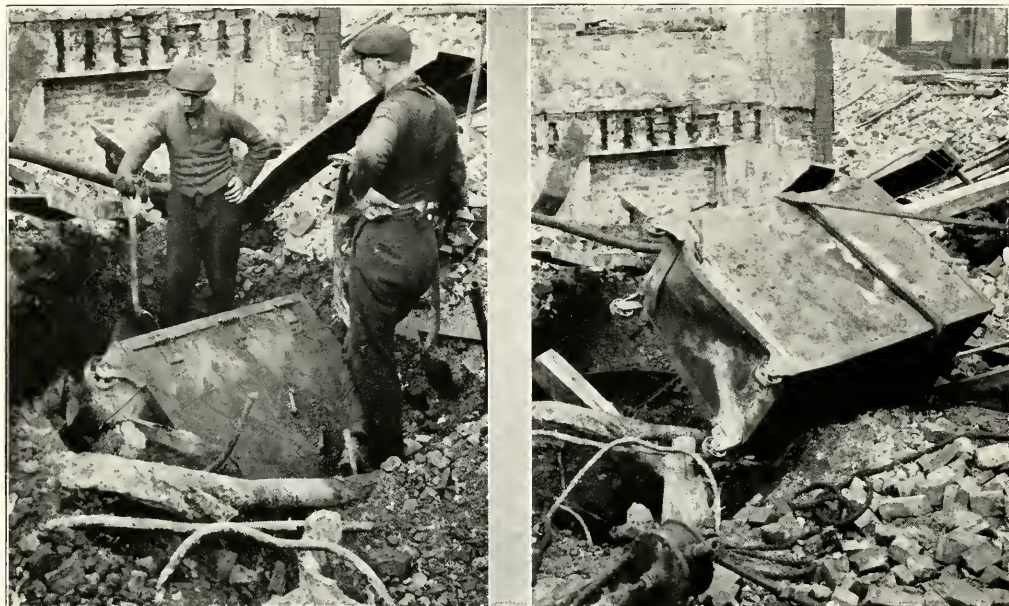
Fig. 10A.

(a) This safe was located on the 6th floor and was dug out of the ruins. See Fig. 10. Its appearance indicates that it was subjected to severe impacts as the angle-iron frame at the back had been badly bent by a blow and the weld between the vertical upright of this frame and the horizontal angle at the top was badly broken. It had also been subjected to severe blows on the frame at the bottom, as the angle-iron frame on this part was badly distorted. The whole frame at the front of the safe had bowed out considerably. The sheet steel forming the back of the member had become separated from the frame at the upper rear corner, presumably from the blow which the frame had received, and this separation extended some distance down the side, but the investigator was advised that some of this separation was due to prying done on the piece after the safe was recovered. The sheet metal forming one of the sides was badly buckled and showed evidence of having been subjected to severe blows. The metal at the top was bulged upward instead of downward, the usual distortion when the safe drops in an upright position. All metal indicated that the safe had been subjected to severe heat. There was evidently some passage

of heat to the interior of the safe as the asbestos packing of the joints was somewhat disintegrated, but this passage of heat was not sufficient to injure any of the contents. The interior appeared to be in a normal condition. The showing of the device under the conditions is considered very satisfactory.

LABELLED "B" SAFE BEING DUG OUT OF RUINS (LEFT). NOTE DAMAGE TO BOTTOM (RIGHT).
THIS SAFE FELL FROM 6TH FLOOR.

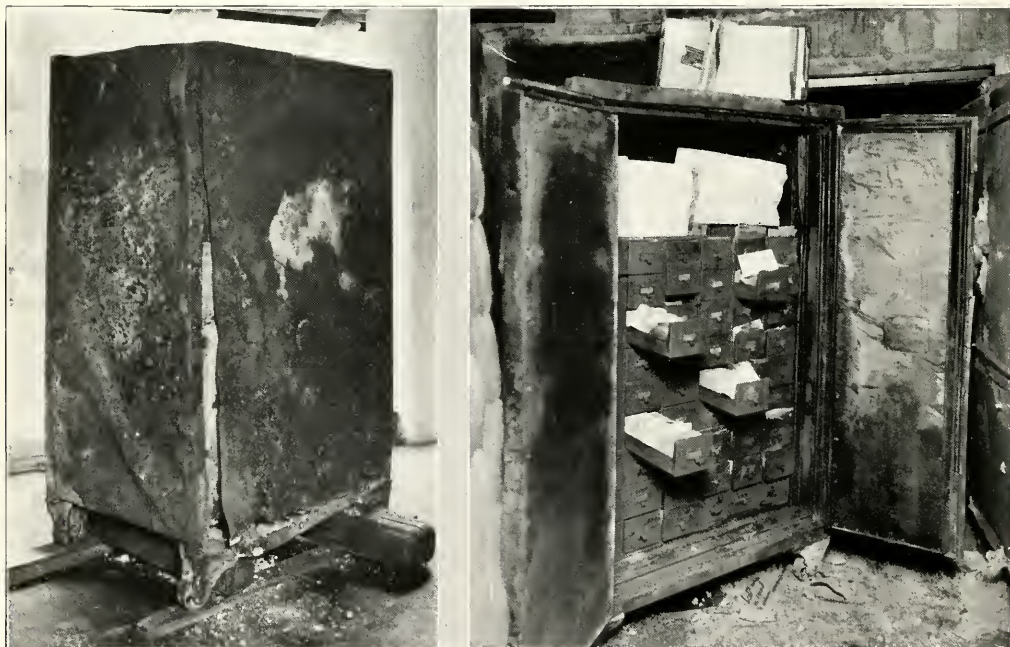
Fig. 10B.

SHOWING DAMAGE TO CORNER OF SAFE (SAME AS 10A), AND CONDITION OF CONTENTS.

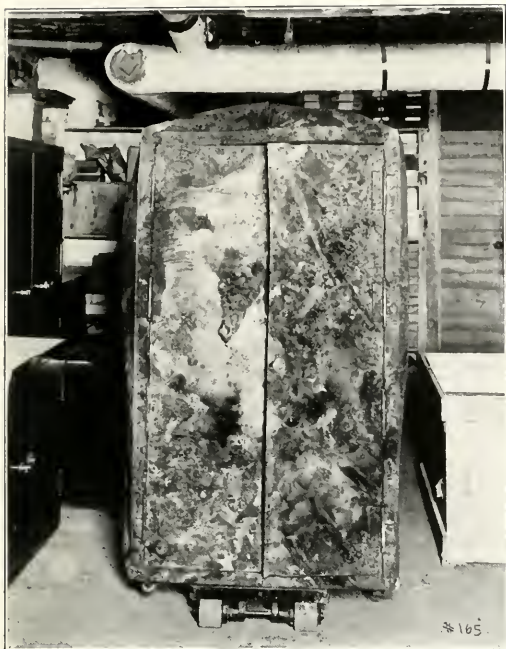
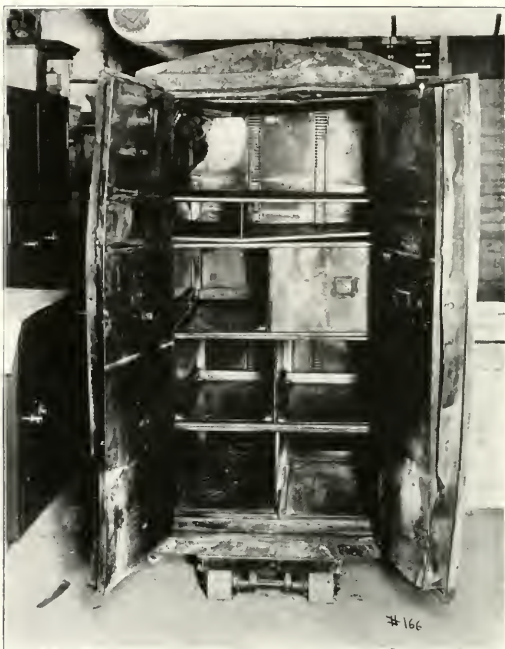
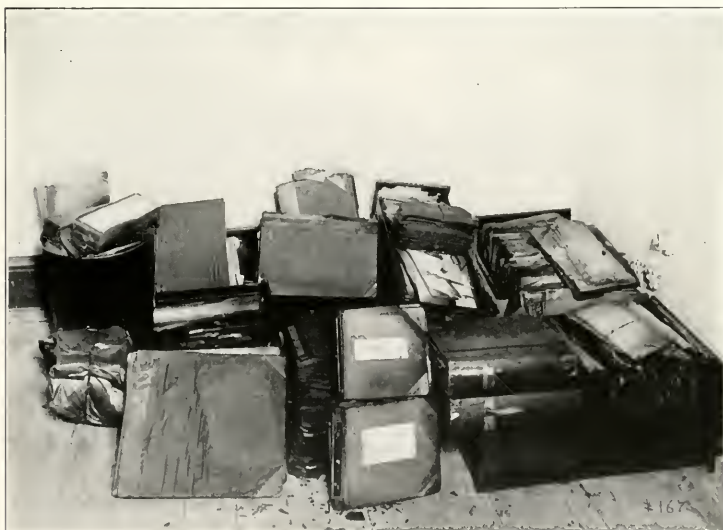
Falling from the third floor to basement, this safe was covered with heavy machinery and burning wreckage from several floors above. See Fig. 11. It had evidently been subjected to severe exposure, as the metal was burned on all sides, except the bottom, and the combination and one handle was melted off. Distortion of the metal also indicated that it had been subjected to severe blows. There was evidently considerable passage of flame at the joints, as noted by the condition of the paint. The owner reported that he was well satisfied with the protection afforded by this receptacle as the only material in the safe which was destroyed was the contents of one drawer which was of little value. There was some charring of the edges of other papers in the safe. It is believed that the penetration of heat into the interior was through the joint which was probably somewhat distorted by the blows to which the safe had been subjected. Credit is given the safe for resisting as much as could be expected of a device of its rating.

Fig. 11A. LABELED INSULATED CABINET WHICH FELL FROM 3D FLOOR.
 Fig. 11B. SHOWING INTERIOR OF SAME CABINET, CONTENTS REMOVED.
 Fig. 11C. CONTENTS REMOVED FROM CABINET (11A).
